MARINE INVESTIGATION REPORT

M07N0117

CAPSIZING AND LOSS OF LIFE

SMALL FISHING VESSEL *SEA URCHIN*
NEWMAN SOUND, NEWFOUNDLAND AND LABRADOR
04 NOVEMBER 2007

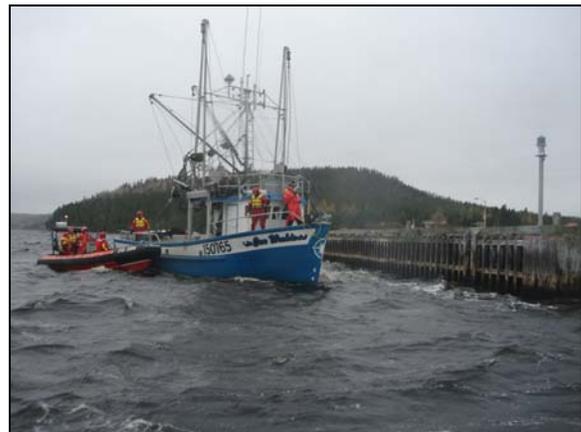
Photo 1. The *Sea Urchin* on the day of the occurrence

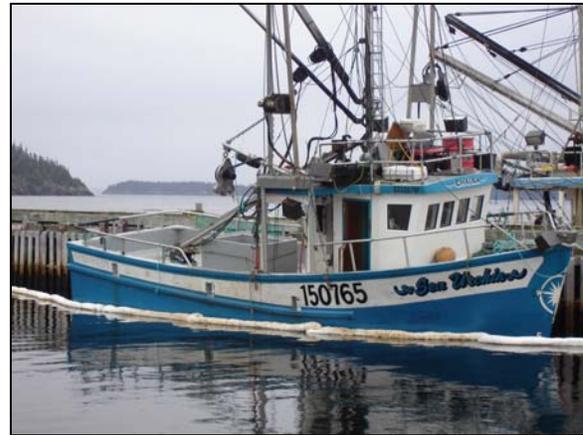
Photo 2. The *Sea Urchin* after recovery
