## **MARINE INVESTIGATION REPORT**

**M12W0070**

### **CAPSIZING WITH LOSS OF LIFE**

**FAST RESCUE CRAFT *LEWIS-MCPHEE*  
SECHELT RAPIDS, BRITISH COLUMBIA  
03 JUNE 2012**

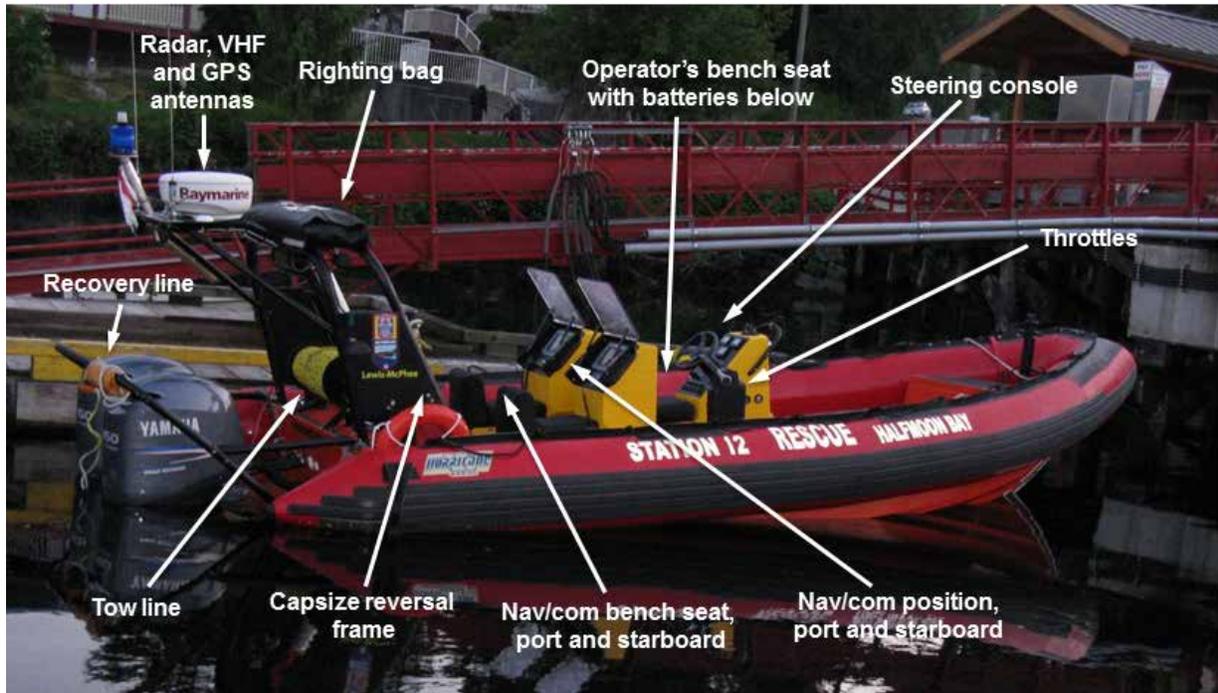
**Photo 1.** RCM-SAR *Lewis-McPhee*

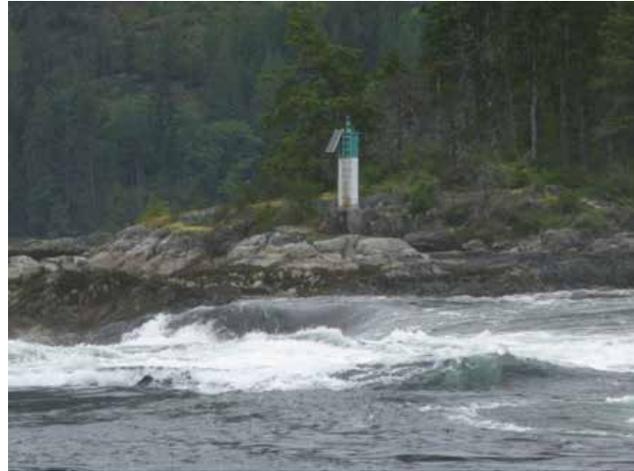
The strongest flood stream occurs to the southeast and west of Sechelt Islets. The strongest ebb stream occurs just west of the green light on Sechelt Islets (Photo 2), with a strong cross-channel set toward the west-northwest. A large back-eddy occurs to the north of the light, and whirlpools form close to the light. On 03 June 2012, the predicted time of maximum ebb current at Sechelt Rapids was 0940, at 13.6 knots. The next predicted time of slack water was 1414.

**Photo 2.** Green light marking southwest extremity of Sechelt Islets

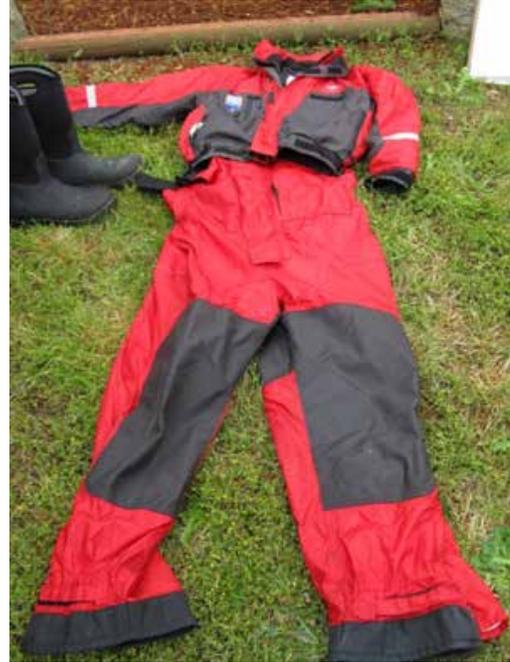
**Photo 3.** Marine anti-exposure suit

RCM-SAR provides crew members with a list of required PPE. All the PPE worn by the crew of the *Lewis-McPhee* was approved by RCM-SAR for their intended operations. At the time of the occurrence, the crew were wearing marine anti-exposure suits (certified as PFDs) that provided thermal and flotation protection. Three of the crew members were wearing the 2-piece suits

(Photo 3), and 1 was wearing the 1-piece suit. All of the crew members were wearing helmets, work boots, and non-flotation mesh crew vests.

The coxswain and surviving crew member were found to be suffering from mild hypothermia when they were rescued. The marine anti-exposure suits they were wearing did not provide sufficient thermal protection, nor did they provide adequate buoyancy while the crew members were in the cold and turbulent waters of Sechart Rapids.
